QUARRY RESIDUALS OPERABLE UNIT INTERIM REMEDIAL ACTION REPORT

WELDON SPRING SITE REMEDIAL ACTION PROJECT
WELDON SPRING, MISSOURI

NOVEMBER 2003

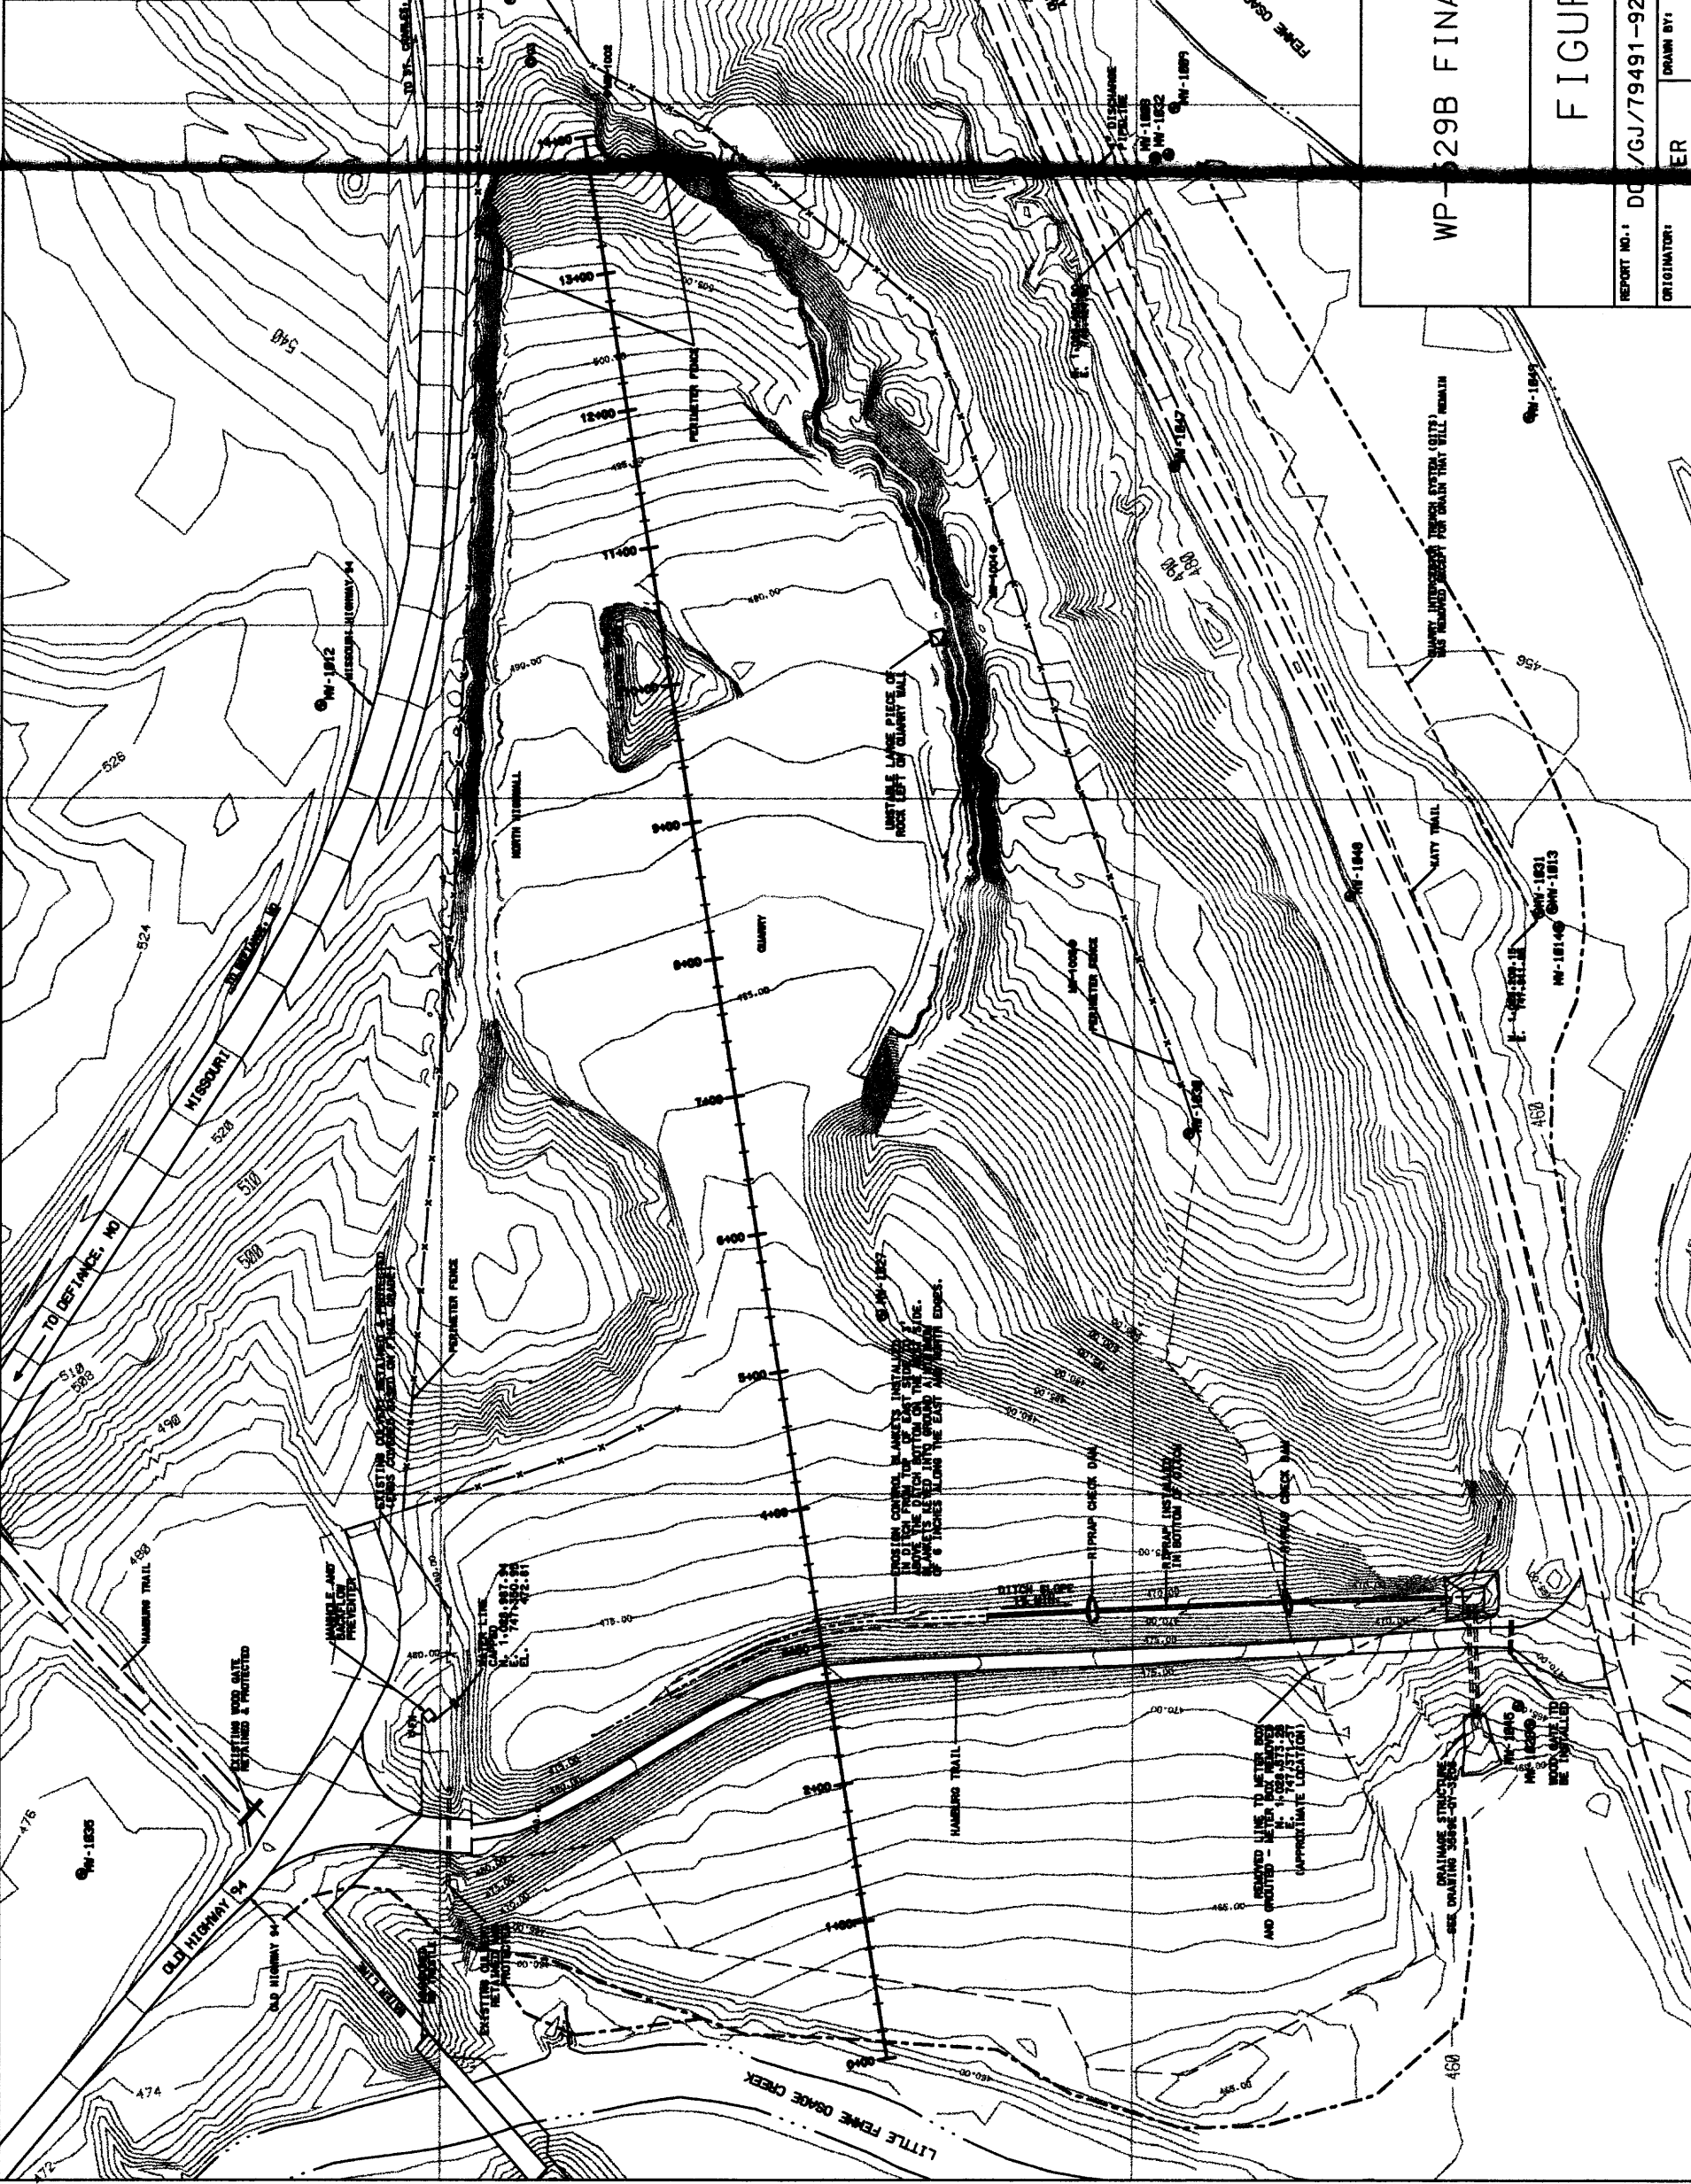
FIGURE 3-12

STATION	GRADE	ELEVATION	CUT/FILL
0+00	EXISTING	460.00	CUT
1+00	EXISTING	473.54	CUT
2+00	EXISTING	472.46	CUT
3+00	EXISTING	482.90	CUT
4+00	EXISTING	482.00	CUT
5+00	EXISTING	482.00	CUT
6+00	EXISTING	483.21	CUT
7+00	EXISTING	480.09	FILL
8+00	EXISTING	471.69	FILL
9+00	EXISTING	474.00	FILL
10+00	EXISTING	509.88	FILL
11+00	EXISTING	479.88	FILL
12+00	EXISTING	486.02	FILL
12+41.56	EXISTING	497.21	FILL
12+76.79	EXISTING	502.27	FILL

WP-29B FINAL GRADING PLAN

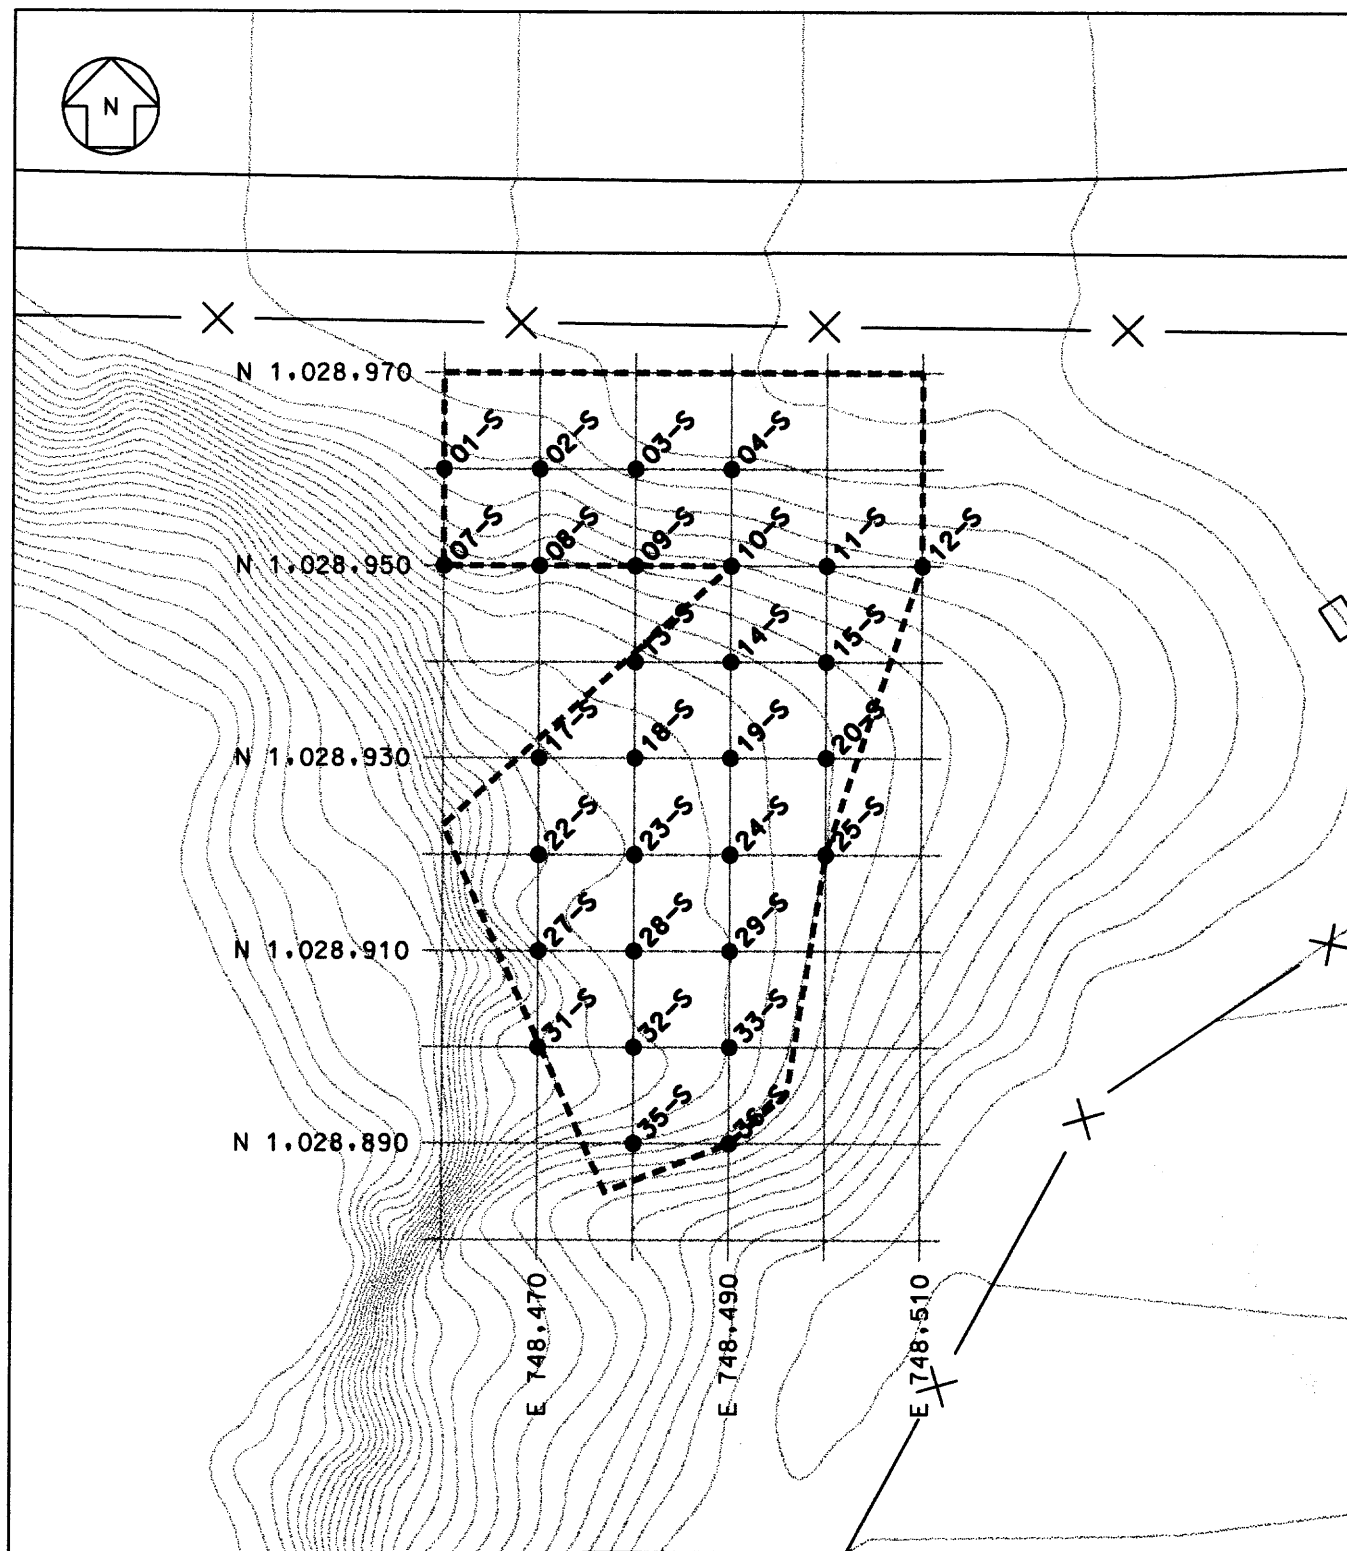
FIGURE 3-17

CONFIRMATION SAMPLING LOCATIONS
AT THE NORTHEAST SLOPE
(RU027; CU411)

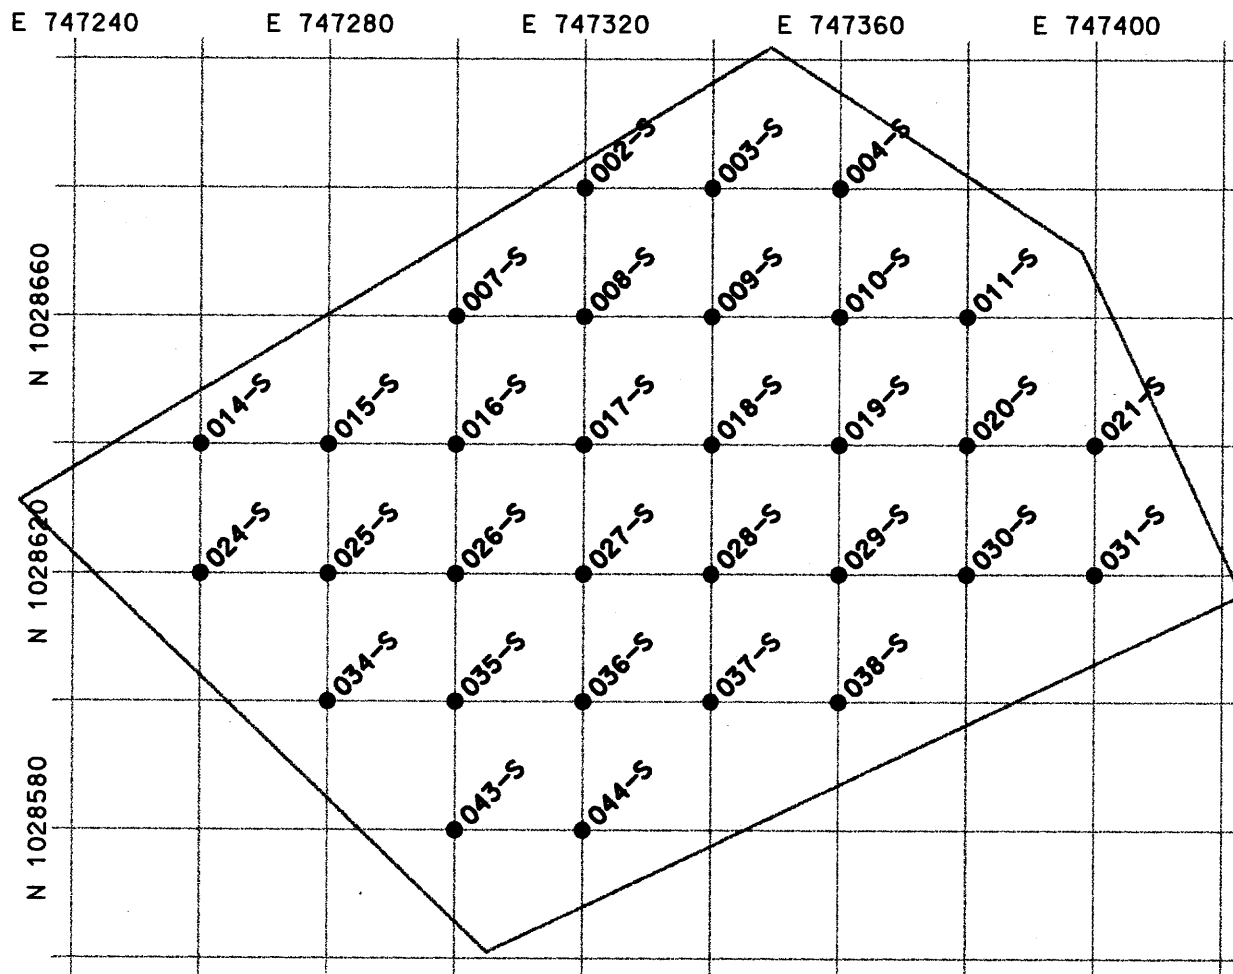
FIGURE 3-24

CONFIRMATION SAMPLING LOCATIONS
QUARRY LAYDOWN AREA
(RU-027; CU420)
